100 Cycle Testing Summary

Elisha Reference – LR 1481

Wheel Stud Scoping GM9540P Protocol

December 5, 2005

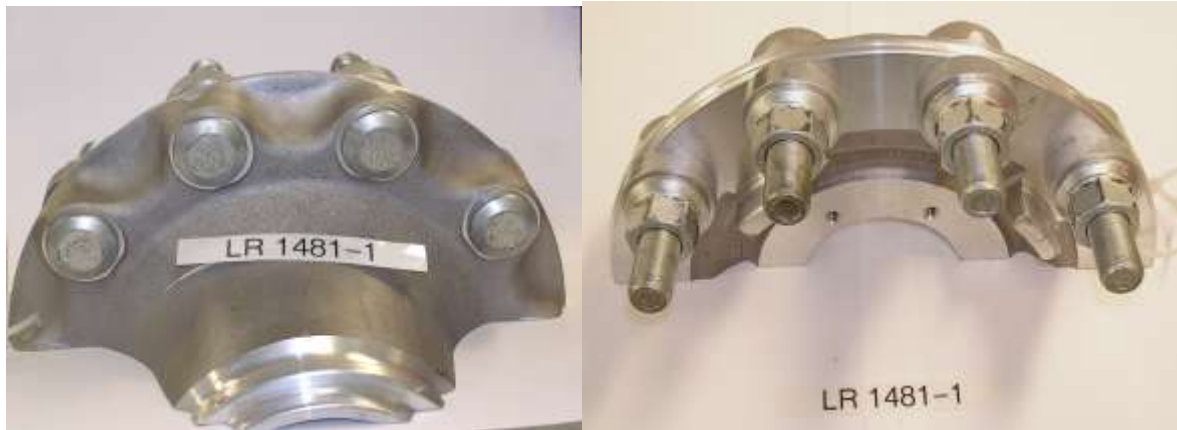
Pre-Testing – Group 1 – Elisha 0250

Note dark areas on edge of nuts indicating damage by installation.

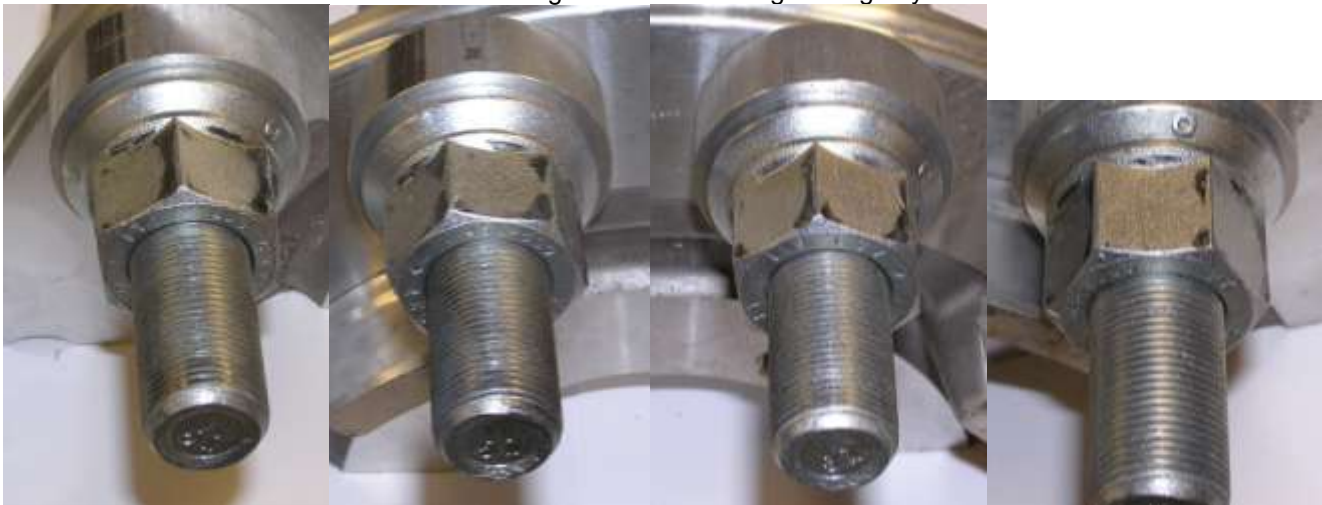
Pre Testing – Group 1 – Elisha 0250

Individual studs prior to corrosion testing.

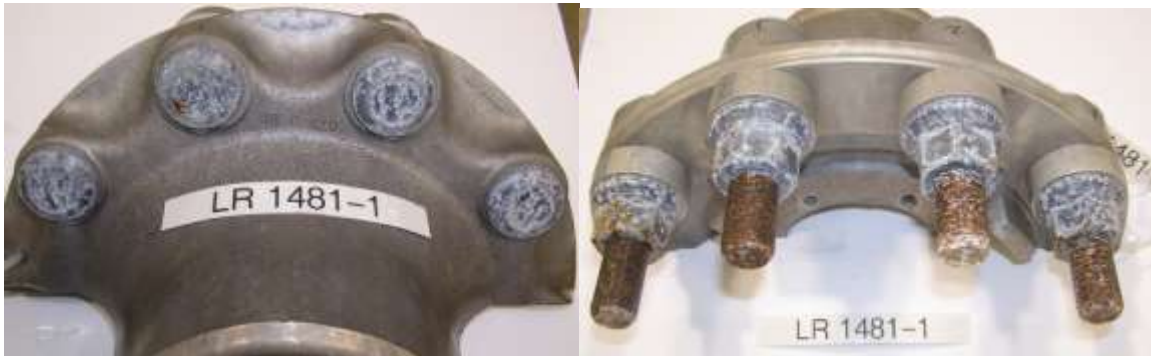
40 Cycles – Group 1 – Elisha 0250

Red rust was first observed at 15 cycles on heads/threads/nut, and 42 cycles on retained washer.

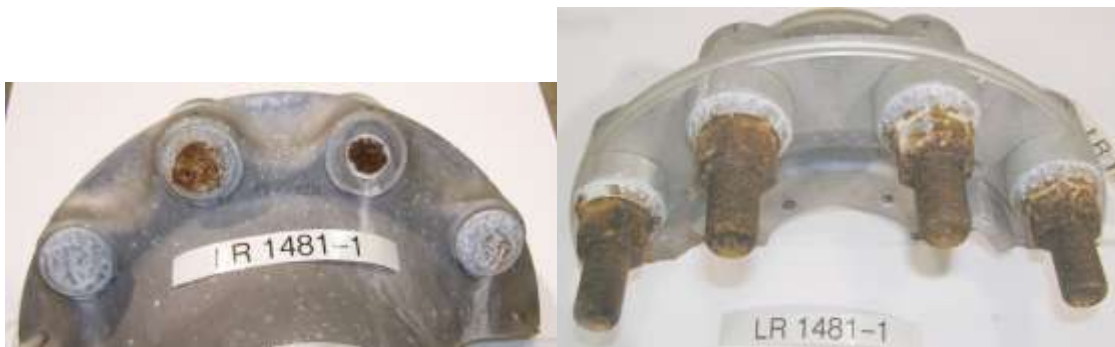
80 Cycles – Group 1 – Elisha 0250

Red rust was first observed at 15 cycles on heads/threads/nut, and 42 cycles on retained washer.
At 80 cycles, threads and nut fully involved in rust. Significant rust on heads.

1. The head of the stud on bolt #1 of group #1 appeared to be dislocated prior to breakaway evaluation. While re-torquing the stud, the head became completely disconnected. The fracture

surface on this stud was completely corroded. The presence of corrosion on this surface indicates that this stud was probably also cracked during the 40 cycle breakaway evaluation allowing for corrosion material and corrosion activity to occur during the 40 cycles since the last breakaway procedure.

In discussion, it was noted that the head of this type of stud can be broken due to improper alignment while installing the stud in the hub. While assembling these hubs, it was necessary to change the stand-off block construction due to deformation. Deformation of the standoff block could change the alignment of the stud as it was being pressed in to the hub, and be a cause of failure previously not investigated. We will evaluate alternative causes for this condition.

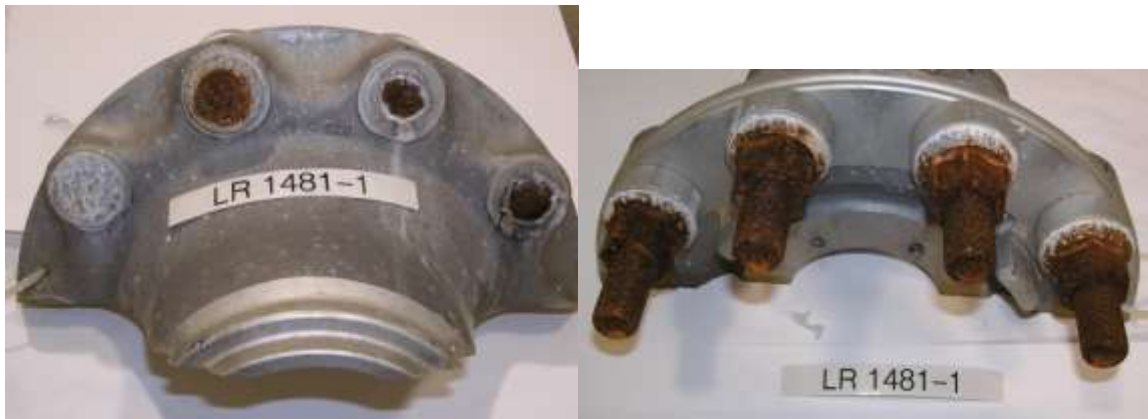
100 Cycles – Group 1 – Elisha 0250

Red rust continued to engage until threads and nuts were fully involved.

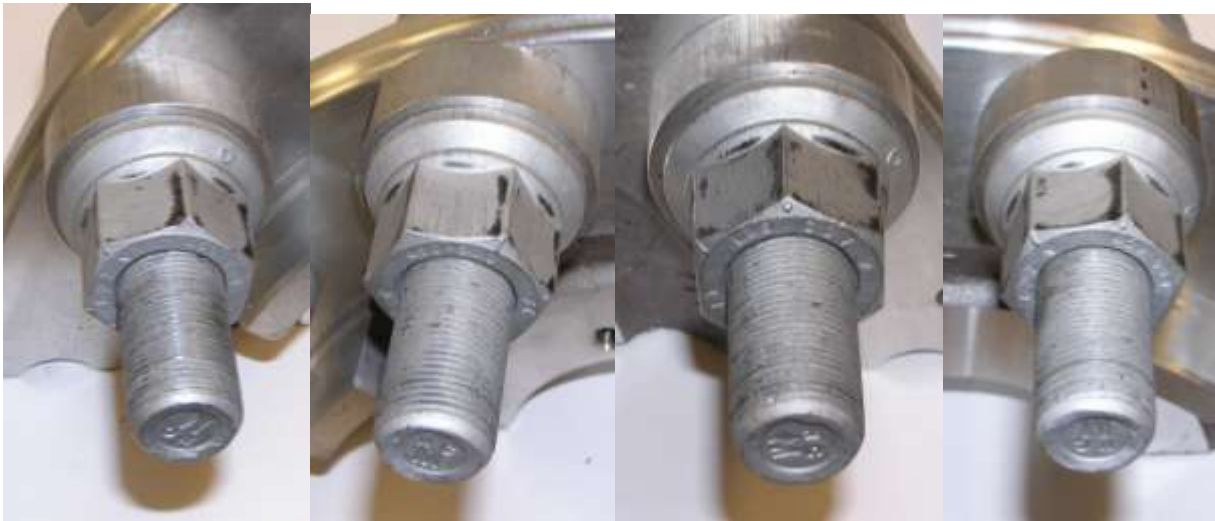
Pre-Testing – Group 2 – Elisha 0251
Individual studs prior to corrosion testing.

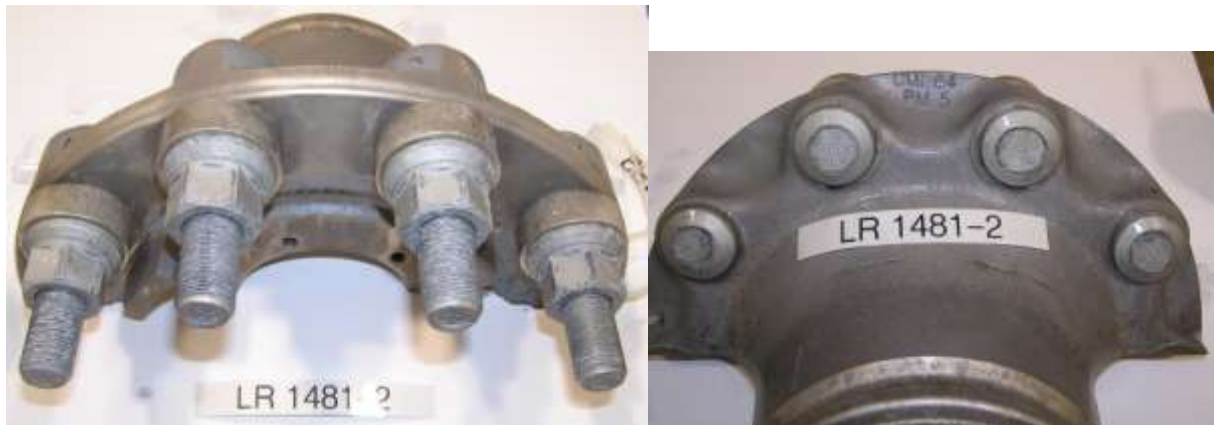
40 Cycles – Group 2 – Elisha 0251
General zinc corrosion (white rust) on threads and damaged areas of nut.

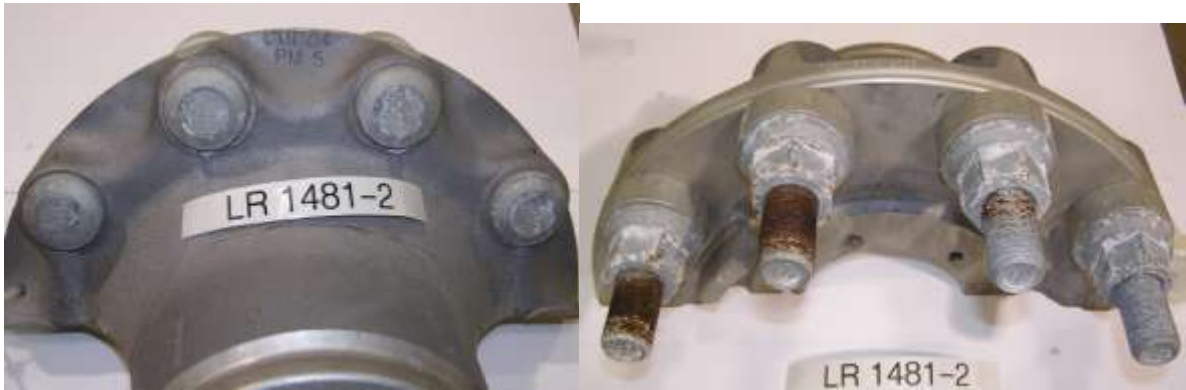
80 Cycles – Group 2 – Elisha 0251

General zinc corrosion (white rust) on threads. Nuts that were broken away at 40 cycles developed significant red corrosion on threads by 80 cycles.

2. The exposed threads on bolt 1 and 2 of Group #2 are experiencing more surface corrosion than the samples which were not subjected to Breakaway and re-torquing evaluation at 40 cycles.

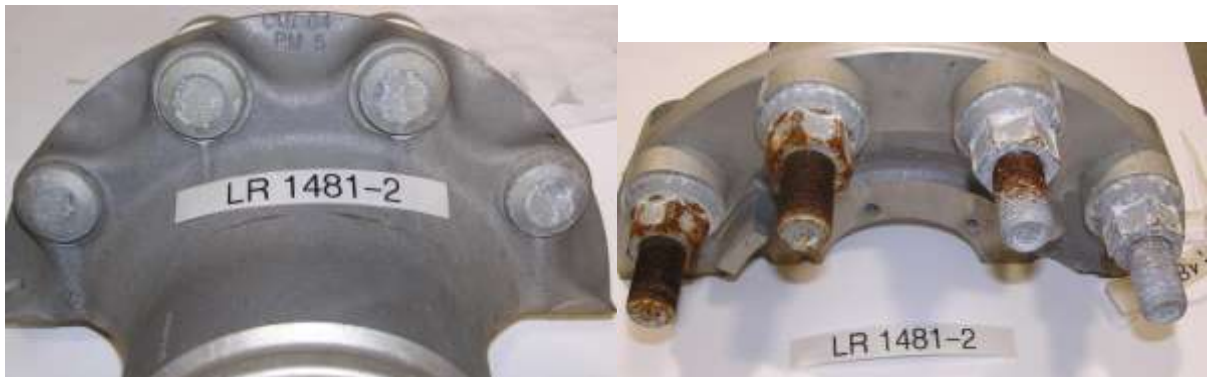
100 Cycles – Group 2 – Elisha 0251

Significant corrosion on threads, especially on bolts that saw multiple breakaway sequences. Heads were clean of red rust at test termination.

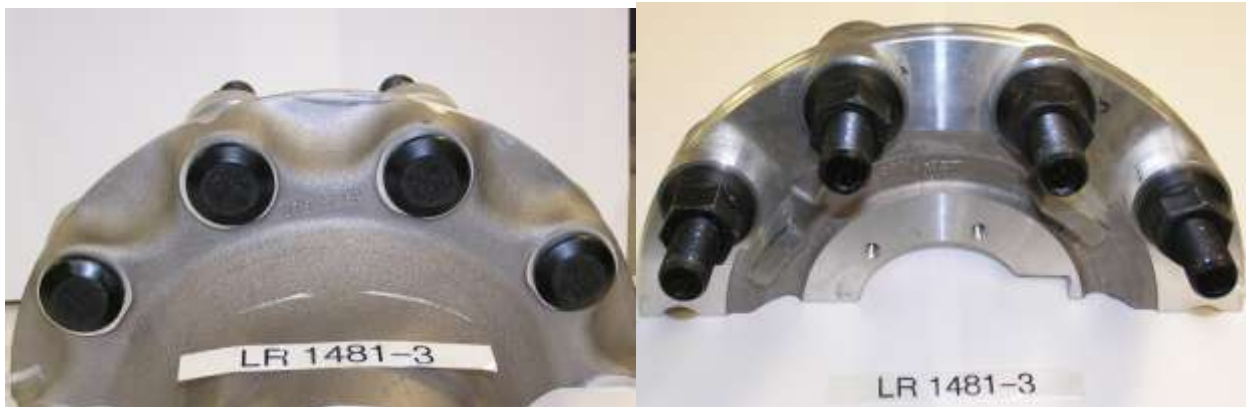
Pre-testing – Group 3 – Elisha 7201

No apparent damage to nuts after installation.

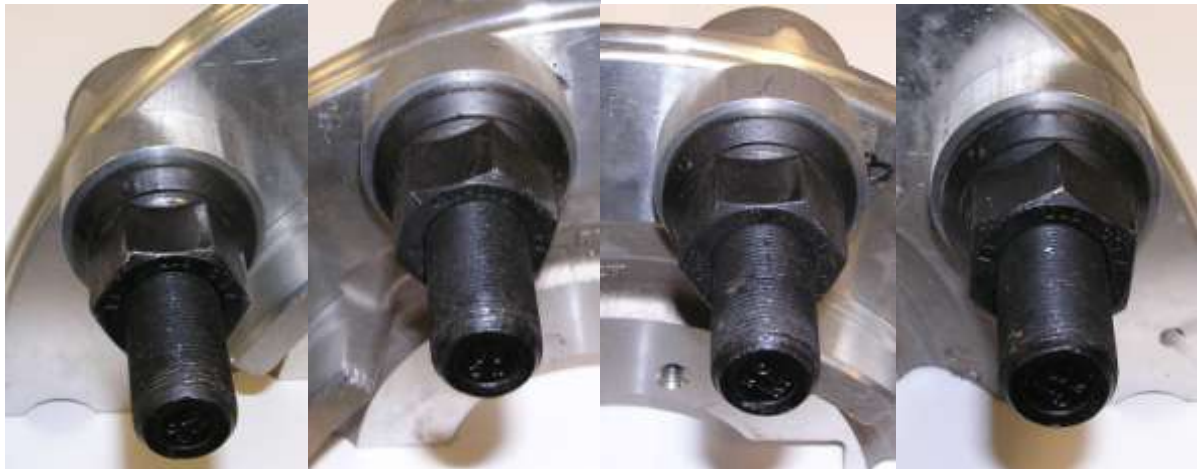
Pre-testing – Group 3 – Elisha 7201
Individual studs prior to corrosion testing.

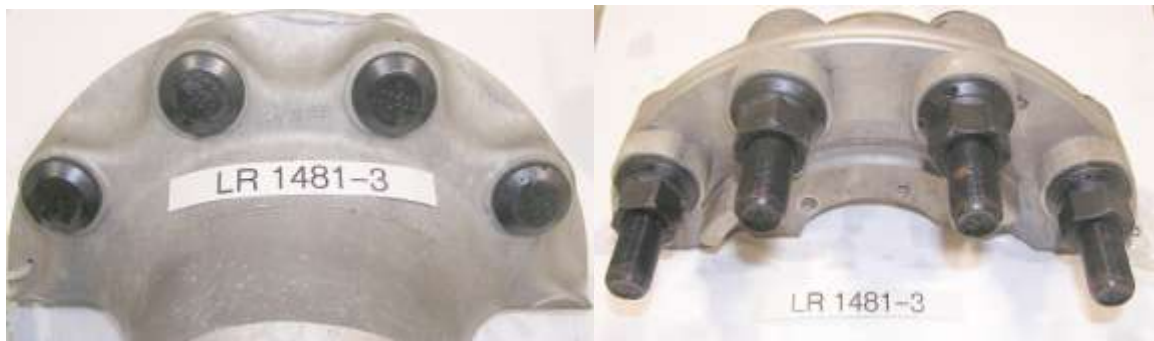
40 Cycles – Group 3 – Elisha 7201

No white corrosion on heads or nut. Red corrosion first observed on heads at 8 cycles, threads at 2 cycles (but note nonprogressional), and 33 cycles on nut. No red on retained washer at 40 cycles.

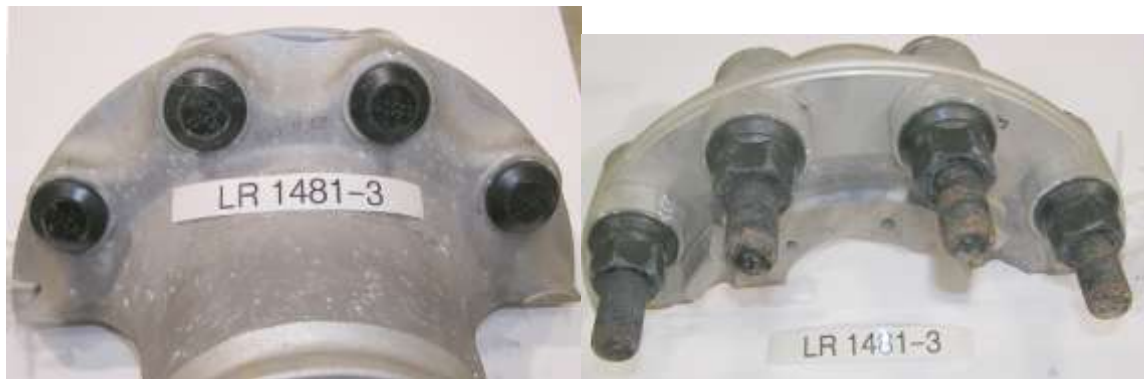
80 Cycles – Group 3 – Elisha 7201

No white corrosion on heads or nut. Red corrosion first observed on heads at 8 cycles, threads at 2 cycles, with progression to significant amounts by 80 cycles. No red on retained washer at 80 cycles.

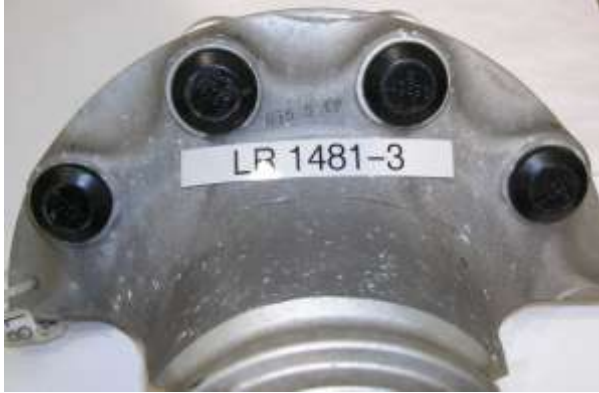
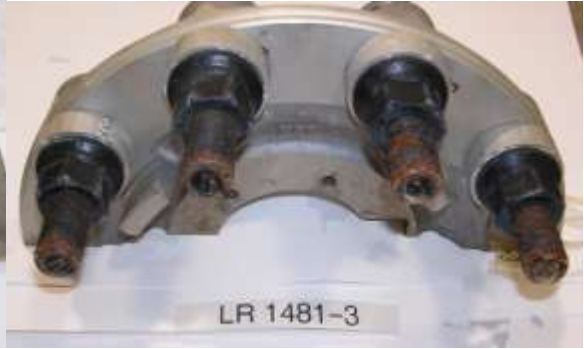
100 Cycles – Group 3 – Elisha 7201

No white corrosion on heads or nut. Red corrosion first observed on heads at 8 cycles, threads at 2 cycles, with progression to significant amounts by 80 cycles. No red on retained washer at 100 cycles.

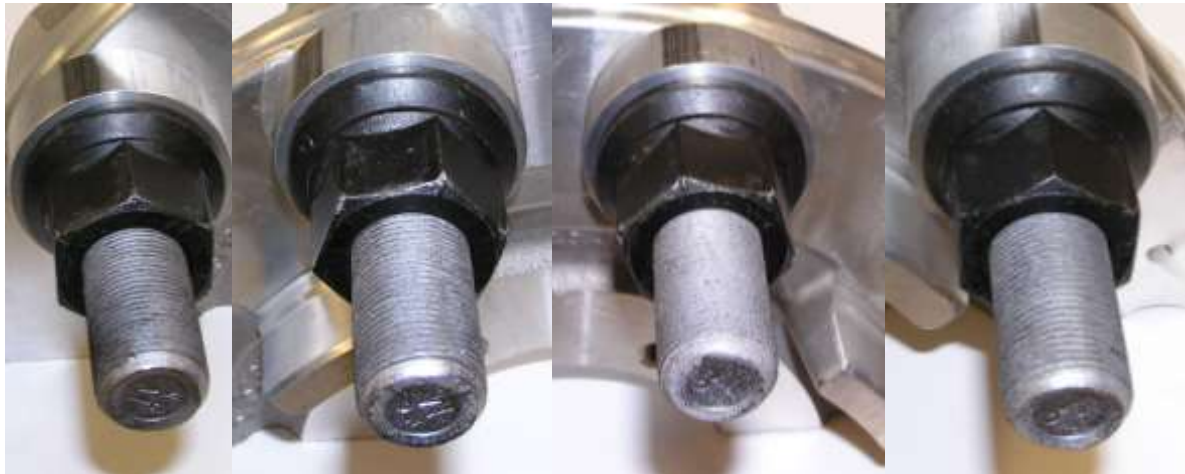
Pre-testing – Group 4 – Elisha 7203 Studs (Elisha 7201 nuts)
Individual studs prior to corrosion testing.

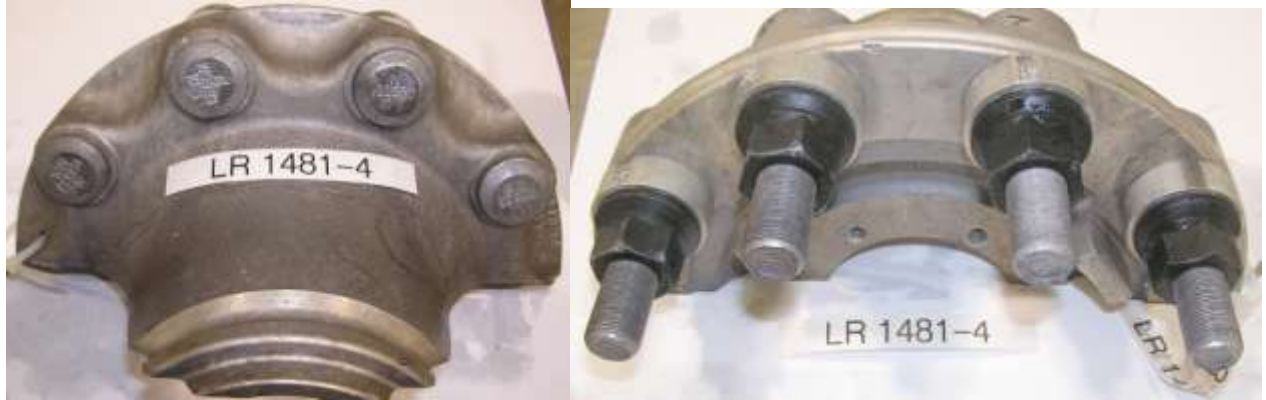
40 Cycles – Group 4 – Elisha 7203 Studs (Elisha 7201 nuts)

No red rust on heads or threads at 40 cycles. Nut first observed red rust at 14 cycles, no red on retained washer.

At the 40 cycle interval, and repeated at both 80 and 100 cycles, the best overall corrosion performance was observed on Group 4 (Elisha 7203). It is recommended that production feasibility analysis be initiated for coating the subject group of parts with Elisha 7203.

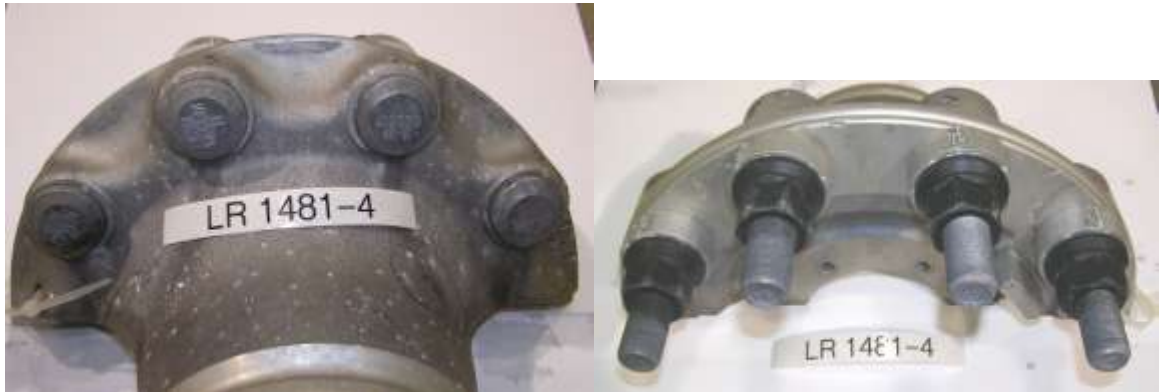
80 Cycles – Group 4 – Elisha 7203 Studs (Elisha 7201 nuts)

No red rust on heads at 80 cycles. First red on threads at 51 cycles on one piece, but not progressing at 80 cycle observation.

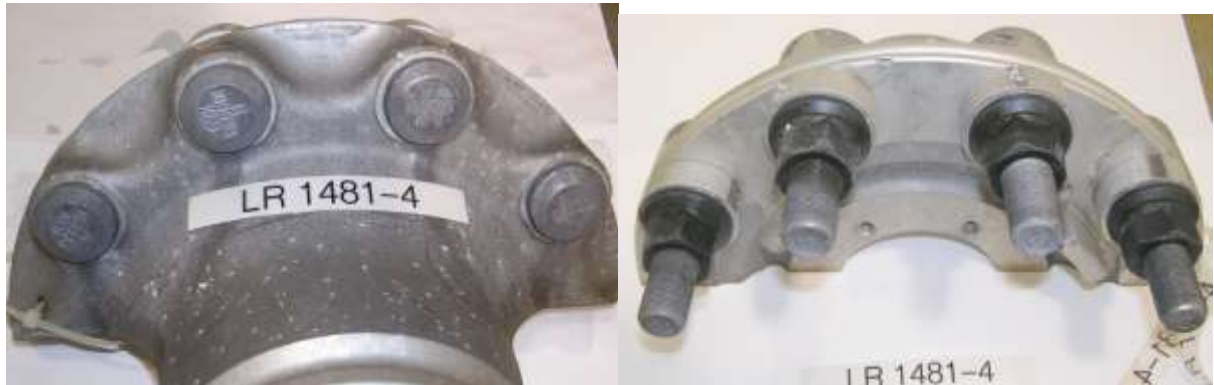
100 Cycles – Group 4 – Elisha 7203 Studs (Elisha 7201 nuts)

No red rust on heads at 80 cycles. No continuation of first red at 100 cycle observation.

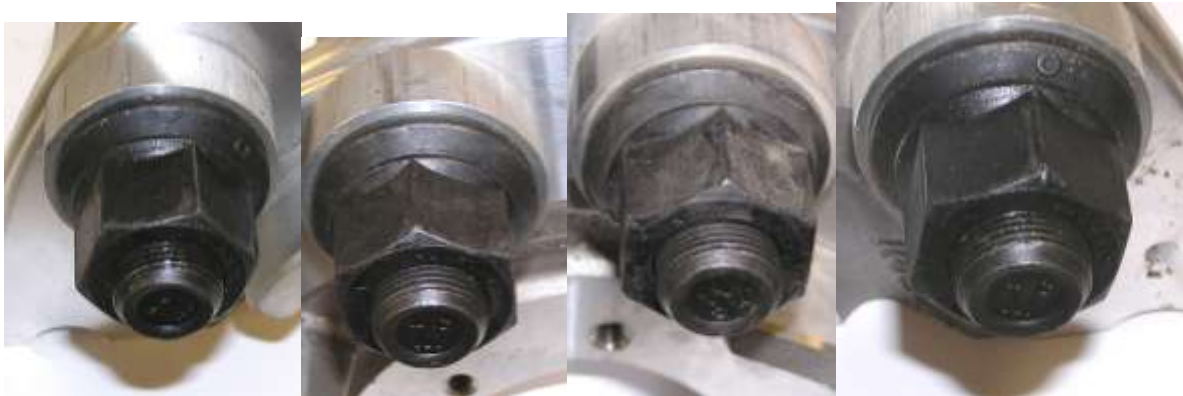
Pre-testing – Group 5 – Current Aluminum Wheel Manufacturer Coating
Individual studs prior to corrosion testing.

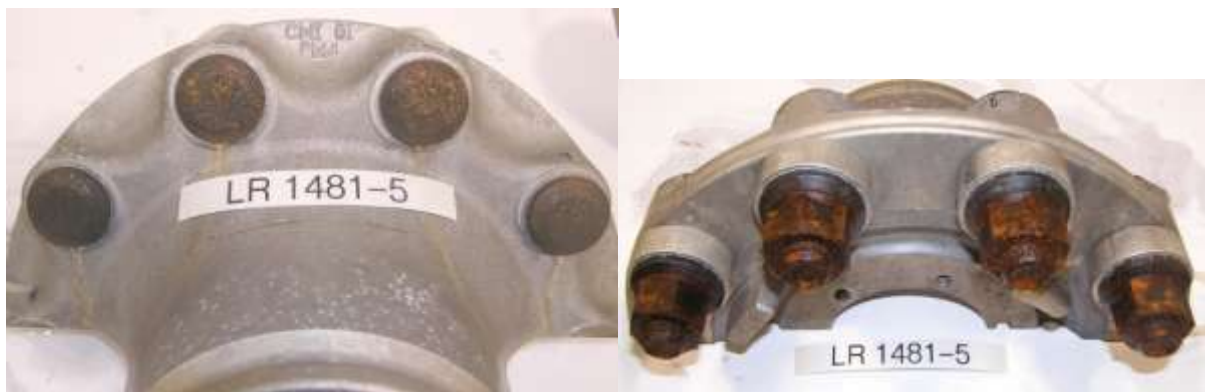
40 Cycles – Group 5 – Current Aluminum Wheel Manufacturer Technology
Threads totally involved in red rust. Extensive base metal (red rust) corrosion in damage areas on nuts.

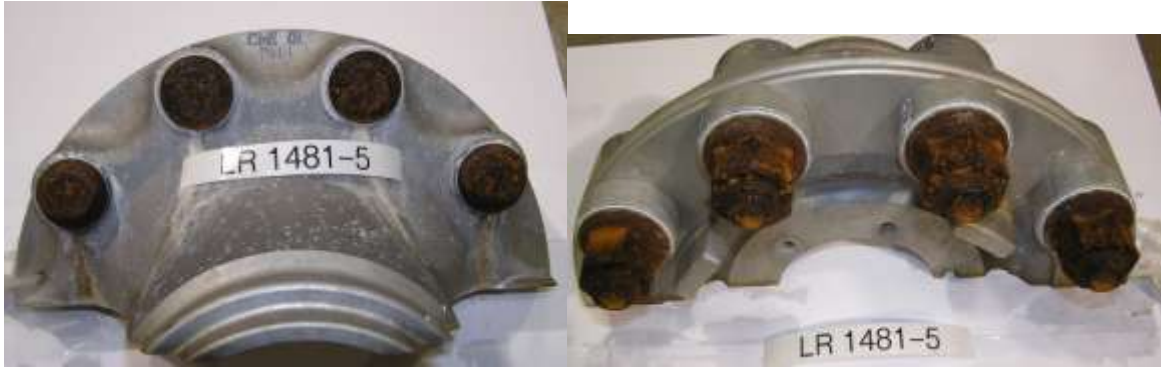
80 Cycles – Group 5 – Current Aluminum Wheel Manufacturer Technology

Entire fastener fully involved in red rust with generation of voluminous corrosion products. According to accelerated corrosion observation data, first base metal corrosion (red rust) on threads was observed at 1 cycle with 5% red rust failure at 4 cycles.

3. Group #5 is experiencing material loss and thread deterioration on stud 1 and 2. Material loss and spalling of corrosion products was noted after the breakaway sequence at 80 cycles.

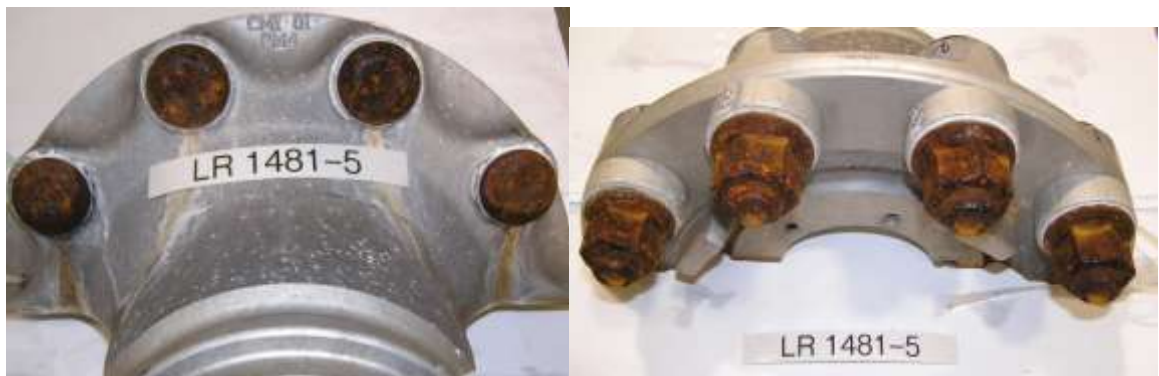
100 Cycles – Group 5 – Current Aluminum Wheel Manufacturer Technology

Entire fastener fully involved in red rust with generation of voluminous corrosion products.
