100 Cycle Testing Summary

Elisha Reference – LR 1481

Wheel Stud Scoping GM9540P Protocol

December 5, 2005

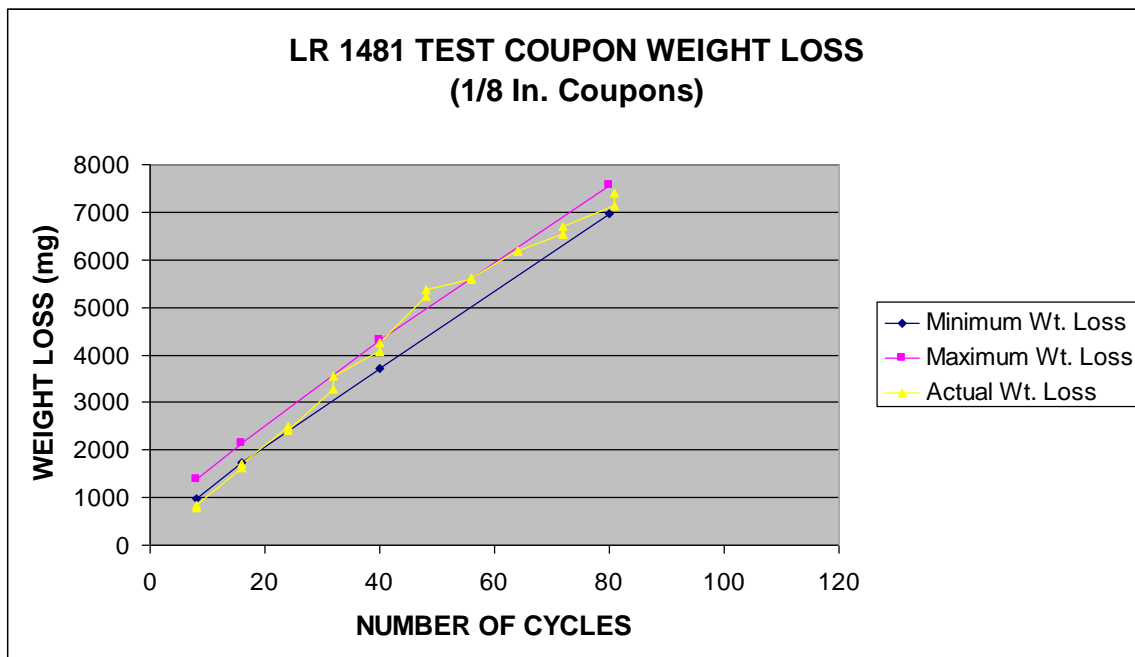
Accelerated corrosion testing is being performed using GM9540P cyclic corrosion test protocol. As required by protocol, weight loss coupons will be used and tracked to determine the corrosion rate experienced during the testing cycle. The weight loss data through 80 cycles is illustrated in the following graph, and is within acceptable limits.
